Failure Analysis of a CH-47 Horizontal Hinge Pin Assembly, P/N 114RS226

ARL-TR-4011

December 2006

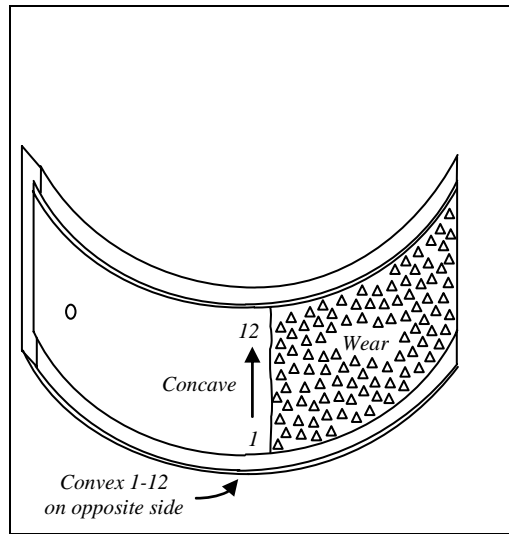
Rockwell C scale hardness measurements performed directly on the concave and convex surfaces of the lead ring were within the 60–64 HRC range drawing requirement (see figure 20 and table 3 and figure 21 and table 4). There was no significant difference in the lead-ring raceway hardness measured adjacent to and away from regions exhibiting wear and spalling. In addition, Rockwell C scale hardness measurements performed directly on the concave and convex surfaces of the lag ring were within the 60–64 HRC range drawing requirement (see figure 22 and table 5 and figure 23 and table 6). There was no significant difference in the lead-ring raceway and lag-ring raceway hardness measured adjacent to and away from regions exhibiting wear and spalling.

Figure 22. Schematic showing location of hardness readings on lag-ring sample, adjacent to wear (see table 5).

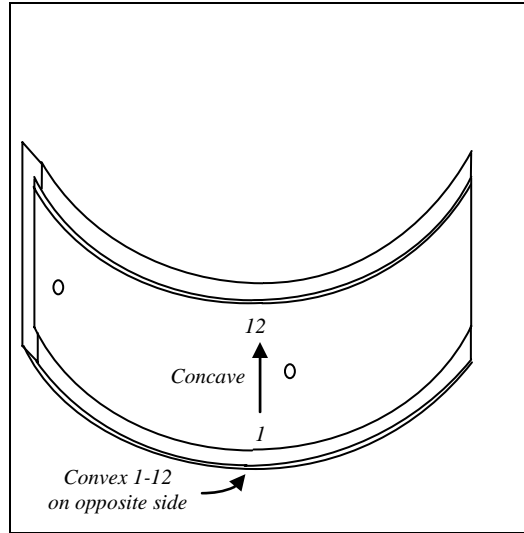
Figure 23. Schematic showing location, of hardness readings on lag-ring sample away from wear (see table 6).
